CASE STUDY

LaGrange Healthcare Facility
PVC Roof Retrofit

60 mil TRITOflex membrane
20 mil TRITOtherm ceramic coat

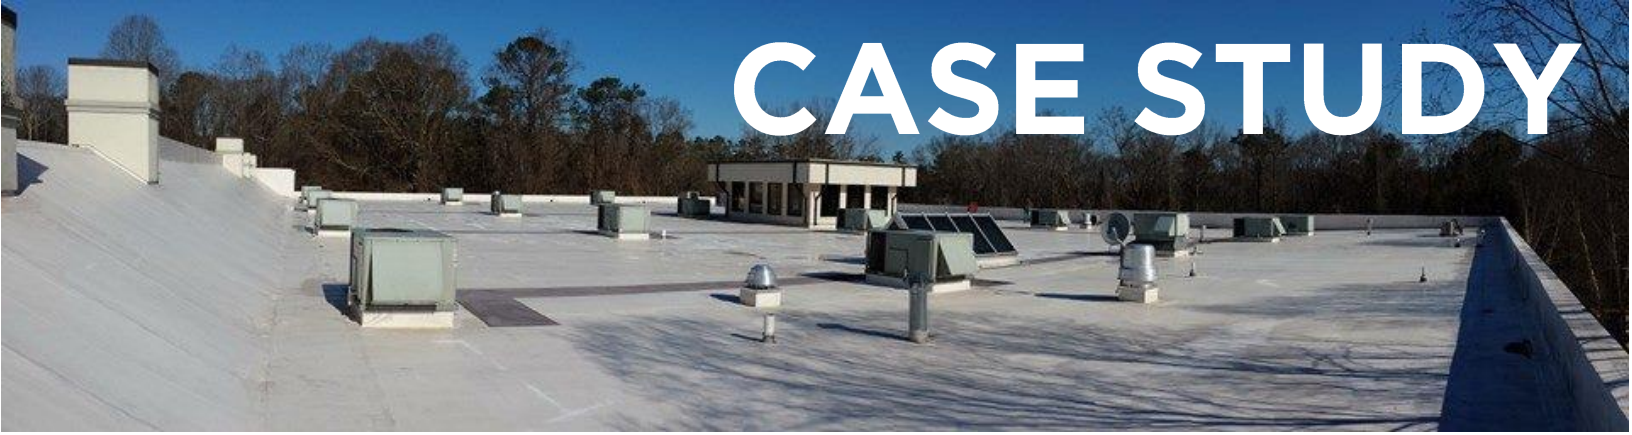
This 10-year old PVC white single-ply roof system had been severely damaged by hail, resulting in numerous membrane fractures and leak points.

After pressure washing and removing all of the walk pads to ensure no moisture was trapped in the existing system, the TRITOflex two-component rubberized membrane was installed in one coat with a spray application directly over the existing PVC single-ply roof system to achieve a 60 mil/1.5mm seamless membrane. It was then top coated with two coats of TRITOtherm thermal insulating coating at 20 mils/0.5mm to provide superior energy cost savings in the hot summers and protect the membrane as a sacrificial layer for decades.
